To: Dometic Steering Cable Customers
From: David Wolfe – Product Manager
Date: August 2022
Subject: Steering Cable Retaining Nut Campaign Notice

The attached Advisory Notice (AN2022005) concerns our Dometic SeaStar Steering Cables, and details how to identify if your Steering System uses a cable within the specific range of affected production cables.

Dometic Steering Cable

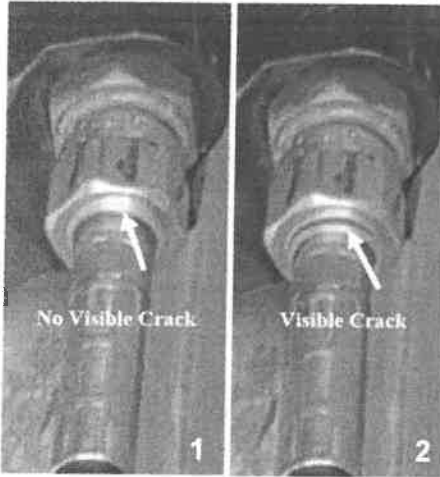
- No further action is required on your part.
- b) On an installed, Fully Tightened nut, the first indication of a defect is a visible crack on the nut shoulder, as shown in **Photo 2**.

NOTE: Any evidence of a visible crack, as shown in **Photo 2**, around the shoulder is a failure. Proceed to **Step 6**.

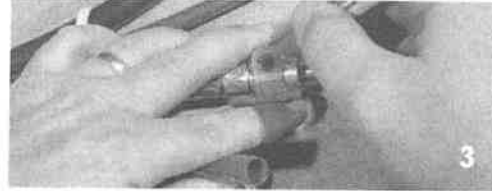
- a) If your cable has been marked on the retaining nut with a green dot shown below in **Photo 3**, the cable has been inspected by the factory and is not defective.

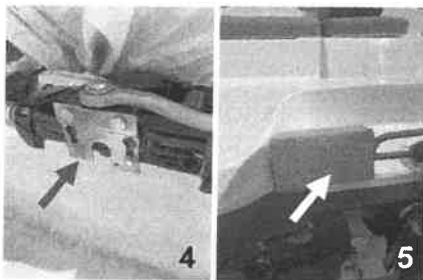
- a) If available, use the shipping brace that comes with your motor to immobilize the motor from turning as shown in **Photo 4**.
- b) If the shipping brace is not available, or your motor does not incorporate this feature, block starboard steering by preventing the output ram and drag link from extending, as shown in **Photo 5**.

- c) With an installed cable and Fully Tightened nut, the initial fitting gap is less than 1/8 inch (0.125") as shown in **Photo 6**. This is also the case for a non-defective cable.

- f) When a Fully Tightened and **Defective** nut is present, any of the following can occur and indicates a failure:
- i. The gap shown in **Photo 7** is larger than 1/8 inch (0.125"),

- ii. The gap shown in **Photo 7** changes length by more than 1/16 inch (0.063"),
 - iii. Any formation of a visible crack as shown in **Step 3, Photo 2**,

- g) On a non-defective cable, with a Fully Tightened nut, the fitting will not move, and will be rigidly fixed with the nut.
- h) If any of the steps above result in failure, the inspection is complete. Proceed to **Step 6**.

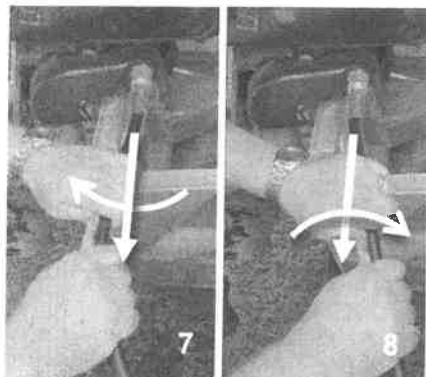
- a) Ensure the retaining nut is **Fully Tightened**.
- b) Grasp the suspect conduit firmly with both hands approximately 4 inches from the end of the conduit fitting as shown in **Photo 7**.
- c) Rotate around the cable and Pull outward away from the retaining nut as shown in **Photos 7 and 8**.

- d) Repeat up to 10 cycles.
- e) On a defective cable, the steel conduit fitting will move significantly with the cranking motion, and the nut shoulder will form a visible crack as shown in **Step 3, Photo 2**, or may sever completely allowing the cable to release from the nut.
- f) If any of the steps above result in failure, your inspection is complete. Proceed to **Step 6**.
